GIPPSLAND PORTS

LNW No.11 OF 2021

PORT OF GIPPSLAND LAKES

No.5 BEACON DAMAGED – TEMPORARY LIGHT ESTABLISHED

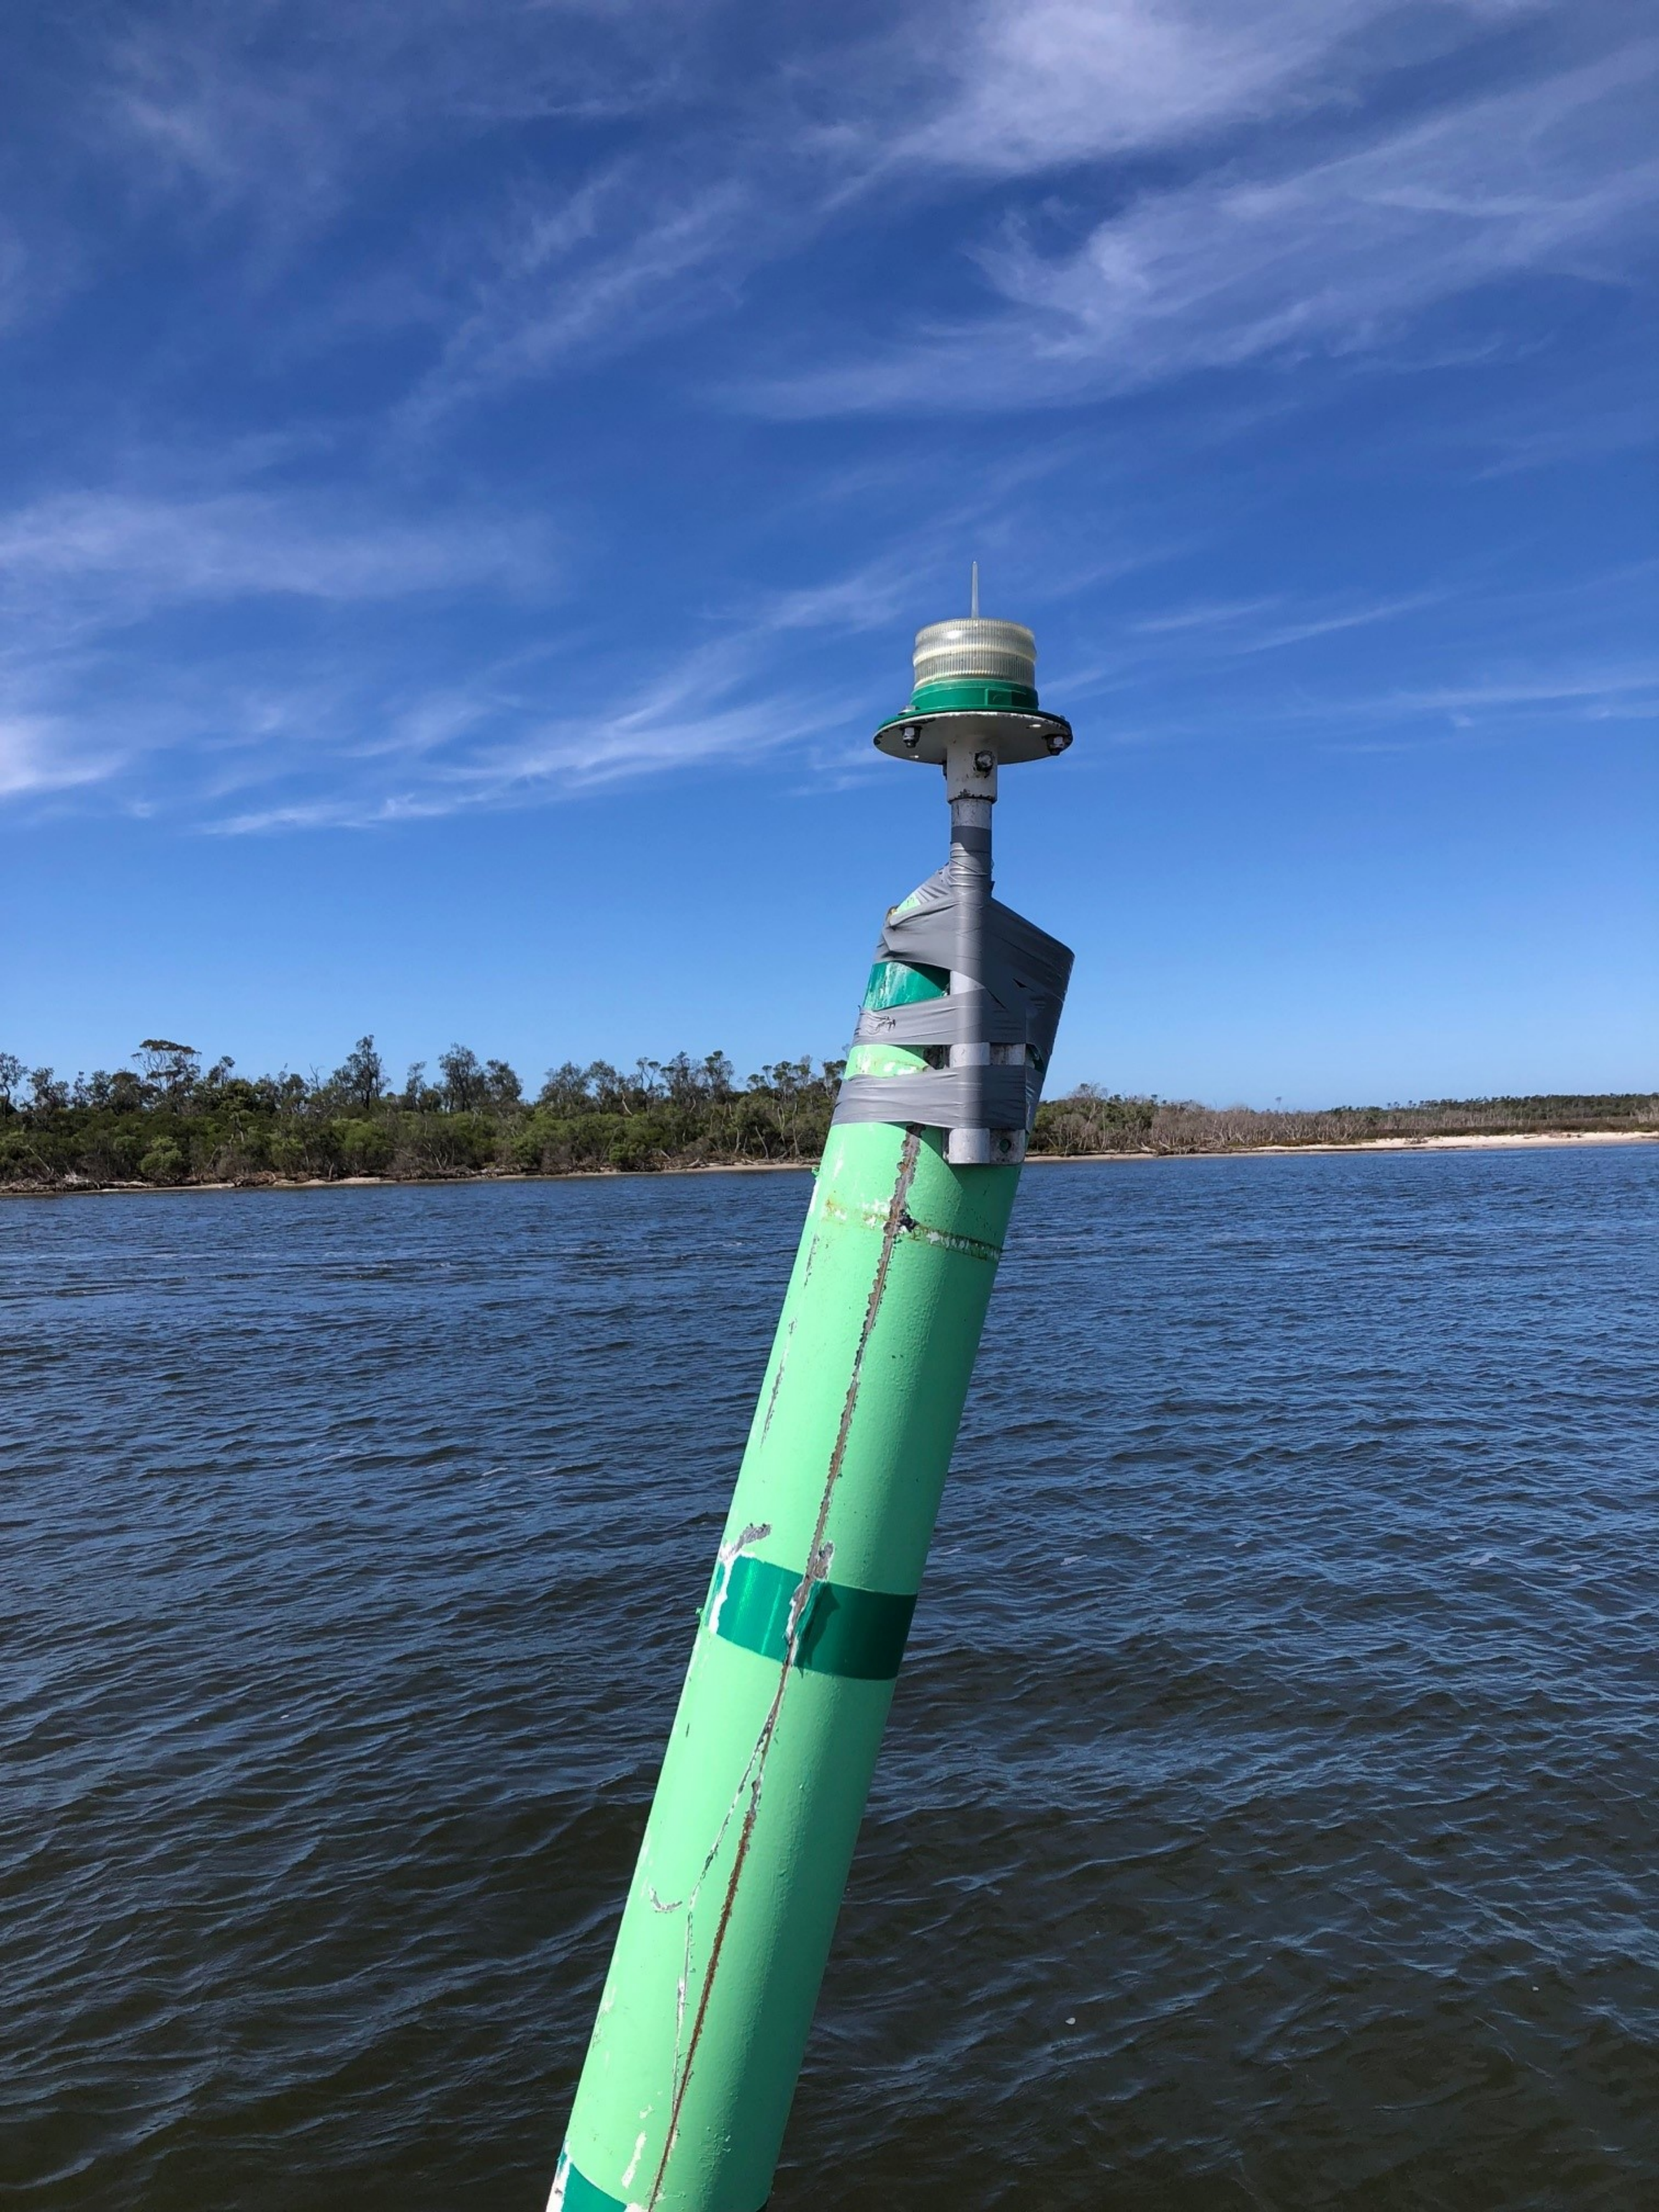
DETAILS: Mariners are advised that the Starboard Lateral Mark No.5 Beacon in The Narrows at Lakes Entrance has been damaged by vessel strike. The position of the No.5 Beacon is;
Lat. 37° 52.919' S
Lon. 147° 57.030' E Datum GDA94

The beacon has a substantial lean upstream and a temporary light (Fl.G.4s) has been re-established to the damaged beacon, pending remedial works to replace. The starboard top mark remains missing from the pile top.

Mariners are advised to take extra precaution when transiting the Narrows channel near No.5 Beacon.
