No. 228(T) OF 2022

PORT OF MALLACOOTA INLET - BASTION POINT BOAT RAMP

NAVIGATION WARNING

APPROACH CHANNEL – ROCKS DISLODGED FROM SEA WALL DEPTHS COMPROMISED WITH RESTRICTED APPROACH ACCESS

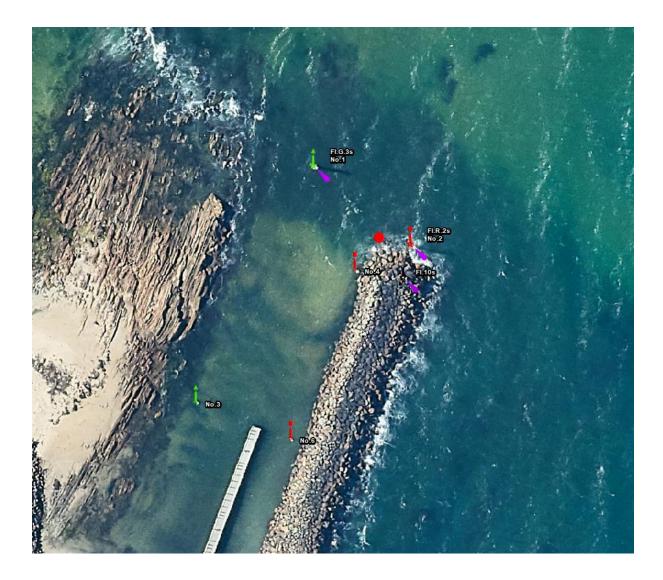
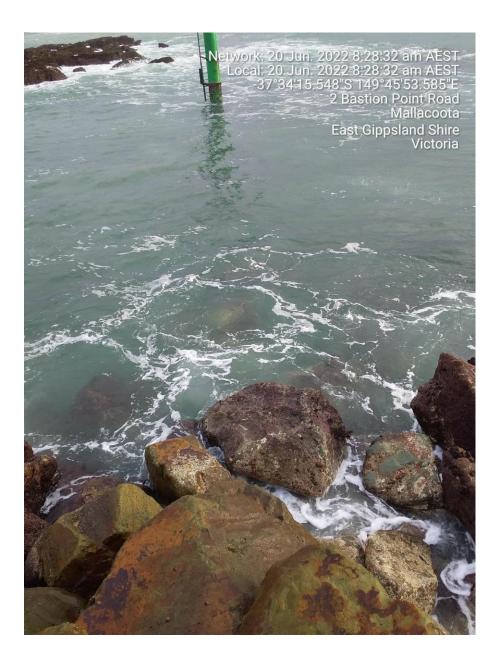
DETAILS: The recent severe weather event causing strong South Westerly wind conditions with damaging seas and swells have dislodged 3 large rocks from the structure of the Bastion Point Breakwater wall at the entrance to the Ocean Access Boat Ramp.

East Gippsland Shire has reported that the rocks are located near the Breakwater wall midway between the Boat Ramp Port Hand Lateral Beacons #2 & #4. The approximate position of the rocks is; Lat. 37° 34.250' S Lon. 149° 45.896' E Datum WGS84

The rocks are compromising the available depth and restricting the approach in that position. The rocks are located in a surf zone and are unable to be marked. East Gippsland Shire will remove the rocks as soon as is practically possible.

Mariners are advised to take extra precaution and avoid entering or departing the boat ramp approach entrance close to the Breakwater wall.
