Australia – Victoria

No. 412 (T) - 2022

PORT OF MELBOURNE PORT PHILLIP BAY EAST CARDINAL MARK BUOY ADRIFT

Date: 21 November 2022

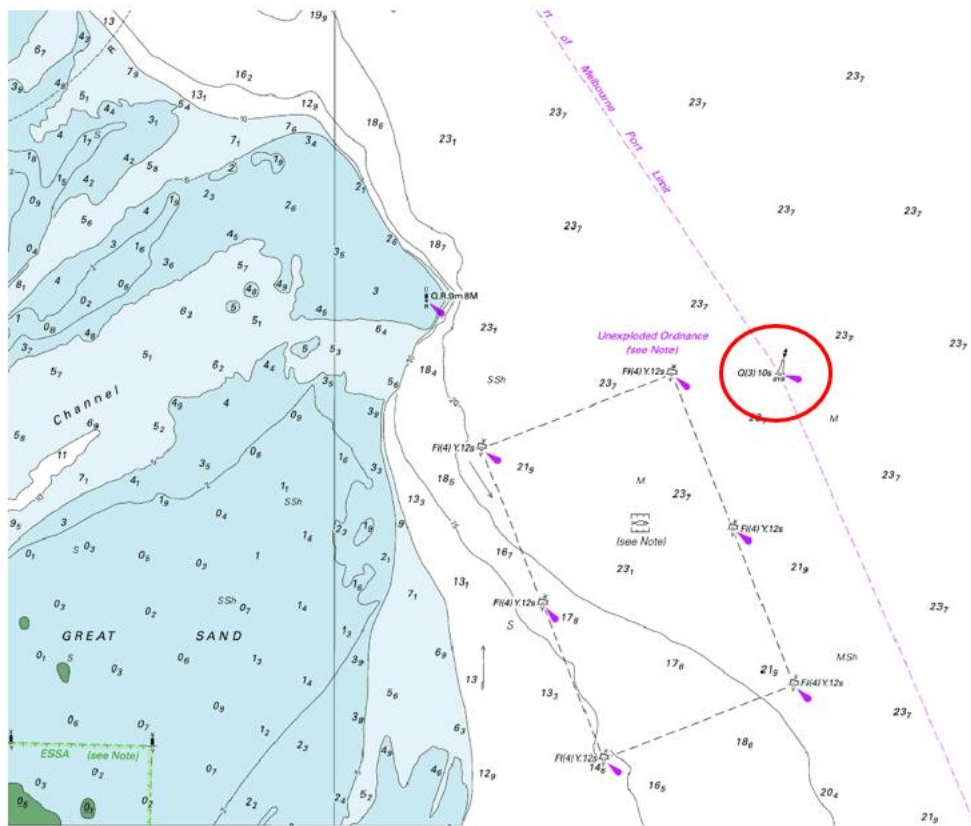
Details: Mariners are advised that the East Cardinal Mark Buoy Q (3) 10s established in the below position is unlit and approximately 250m west from its established position in Port Phillip Bay.

Mariners are advised to navigate with caution in the vicinity of the drifting buoy.
