## **Victorian Notice to Mariners**

## No. 044 (T) - 2023

## PORT OF MELBOURNE PORT MELBOURNE CHANNEL-SOUTH REDUCTION IN MAINTAINED DEPTH

Date: 25 January 2023

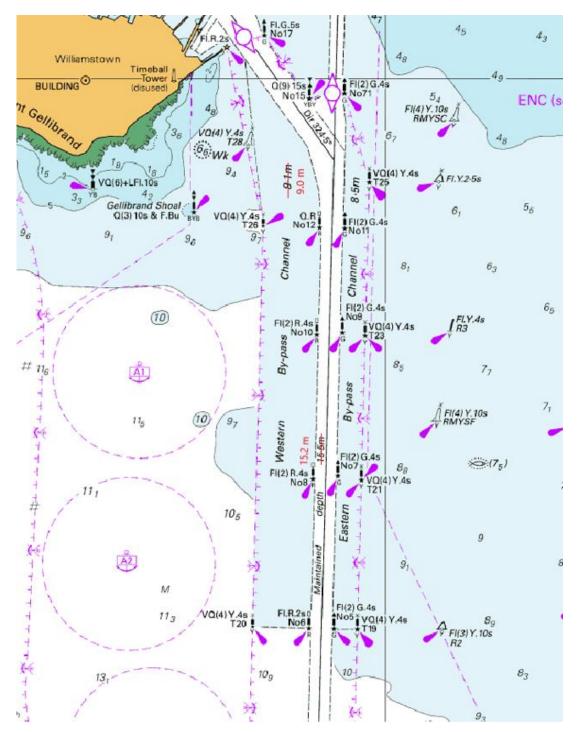
**Details:** Mariners are advised that a reduction in maintained depth has been declared for the Port Melbourne Channel-South.

Port Melbourne Channel-South - reduction in maintained depth
