No. 197(T) OF 2023

PORT OF MALLACOOTA INLET - BASTION POINT BOAT RAMP

NAVIGATION WARNING

APPROACH CHANNEL – ROCKS DISLODGED FROM SEA WALL

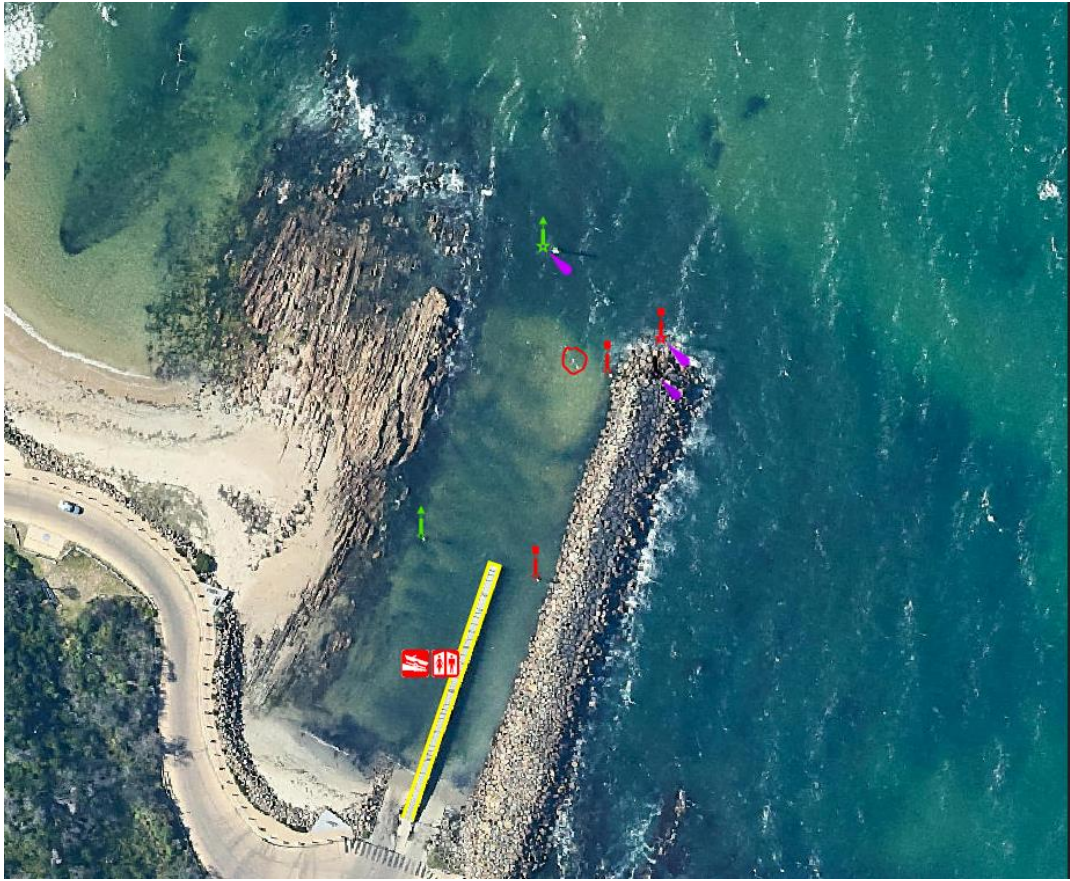
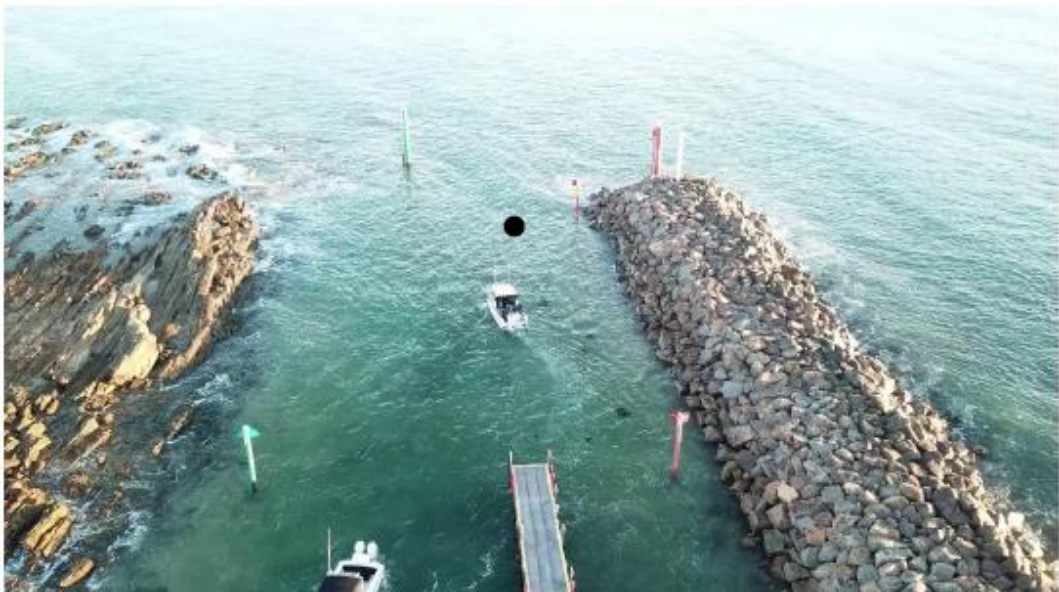
DETAILS: A recent weather event causing strong wind conditions with damaging seas and swells have dislodged 3 large rocks from the structure of the Bastion Point Breakwater wall at the entrance to the Ocean Access Boat Ramp.

East Gippsland Shire has reported that the rocks are located near the Breakwater wall approximately 10m into the channel from No 4 Port hand lateral mark beacon. The approximate position of the rocks is;

The rocks are compromising the available depth and restricting the approach in that position. The rocks are located in a surf zone and are unable to be marked. East Gippsland Shire will remove the rocks as soon as is safe and, practically possible.

A photograph and map indicating the position of the rocks is attached to this Notice.

Removal of the rocks requires Dive Operations when environmental conditions are suitable. At that time East Gippsland Shire may need to close the Boat ramp while the dive operations are taking place. East Gippsland Shire will have traffic management personnel in place to direct vehicle and vessel traffic as necessary.
