**NOTICE TO MARINERS No.223 OF 2023**

**PORT OF MALLACOOTA INLET**

**BASTION POINT BOAT RAMP**

**HAZARDOUS ROCK REMOVED – ISOLATED DANGER BUOY  
ESTABLISHED**

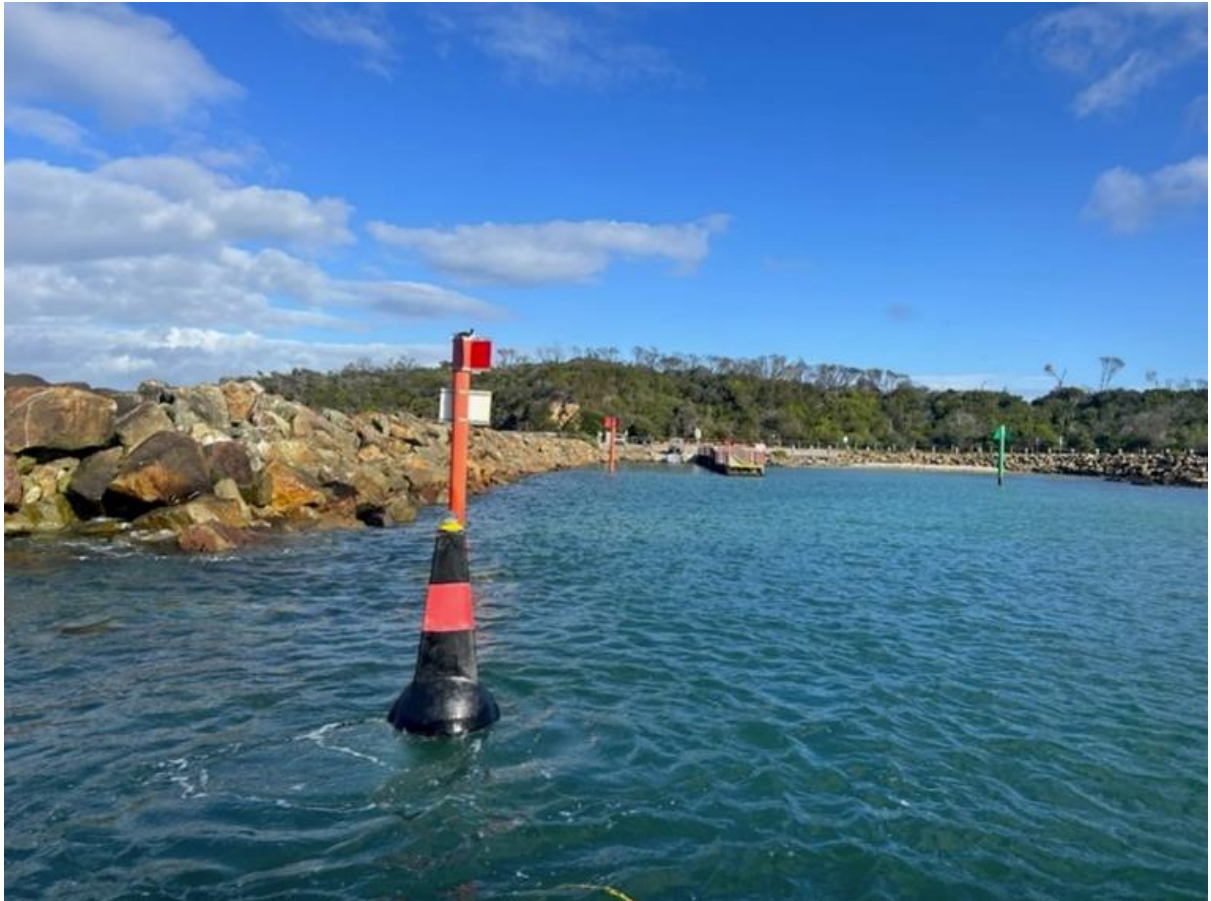
**DETAILS:** Mariners are advised that hazardous rock previously located approximately 10 metres into the approach channel at Bastion Point Boat Ramp has been removed by dive operations and relocated to the seaward side of the breakwater rock wall.

Other rocks (approximately 9 in number) which have slid down the toe of the breakwater near No.2 Lateral Mark Beacon (Fl.R.2s) have been left in place to stabilize against further rockfall. The outer limit of these rocks lies approximately 4 metres from the low water mark of the rock wall and have been marked with an **unlit** Isolated Danger Mark Buoy. The rocks are not compromising depths in the boat ramp approach channel. The position of the isolated danger buoy is;

See attached photo.

Mariners are advised to take extra precaution and avoid entering or departing the boat ramp and entrance close to the toe of the rock wall structure.
