## **Victorian Notice to Mariners**

## Australia – Victoria No. 346 (T) - 2023 PORT OF MELBOURNE PORT MELBOURNE CHANNEL-SOUTH BEACON 8 OFF STATION

Date:	20 August 2023
-------	----------------

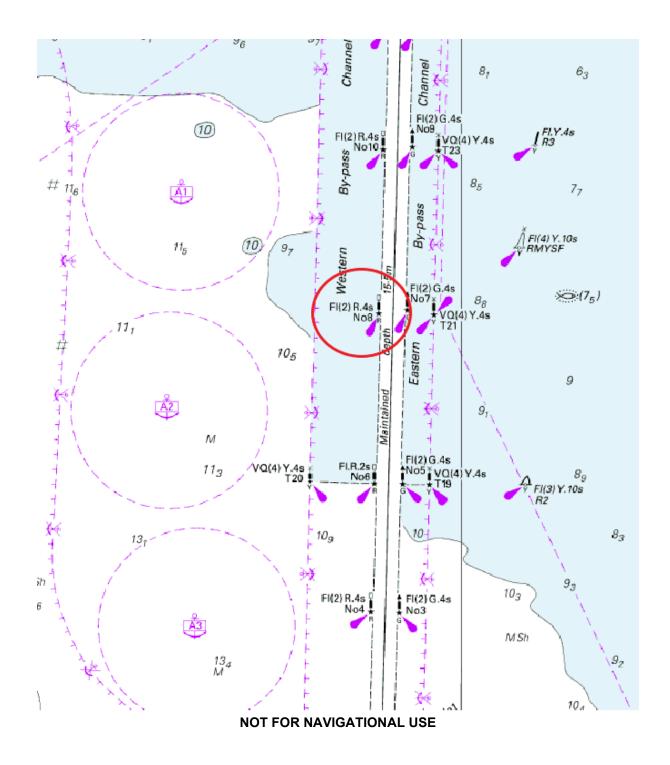
Details: Mariners are advised that Port Melbourne Channel-South Beacon 8 located in position 37° 53.856' S 144° 55.577' E is off station.

The beacon is lying on the seafloor immediately to the northeast of its charted position. The beacon presents an obstruction as follows:

- Beacon 8 charted position: least depth of 8.6m
- Beacon 8 extremity to the northeast: least depth of 13.4m

A virtual aid to navigation **TB12** is established at the northeast extremity of the beacon in the following position: **37° 53.850' S 144° 55.588' E**

## Mariners are advised to navigate with additional caution in the vicinity of Port Melbourne Channel-South Beacon 8 and TB12.

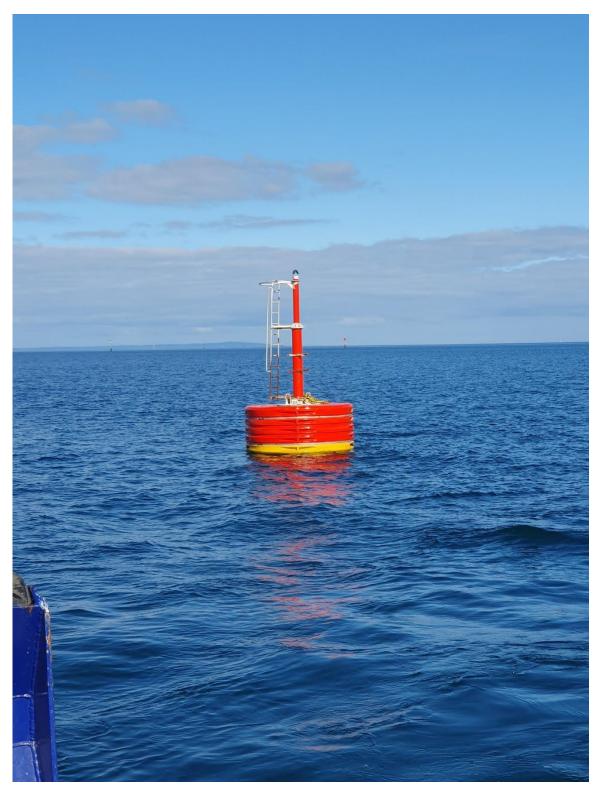
## **TEMPORARY BUOY**

A port hand lateral mark buoy has been deployed directly to the north of the fallen beacon position, details as follows:

Buoy	Characteristic	Approximate Position
Port hand lateral mark	FI(2)R.4S	37° 53.829' S 144° 55.587' E
(without top mark)
