Australia – Victoria

No. 360 (T) - 2023

**PORT OF MELBOURNE
WEBB DIRECTIONAL LIGHT UNRELIABLE**

Date: 6 September 2023

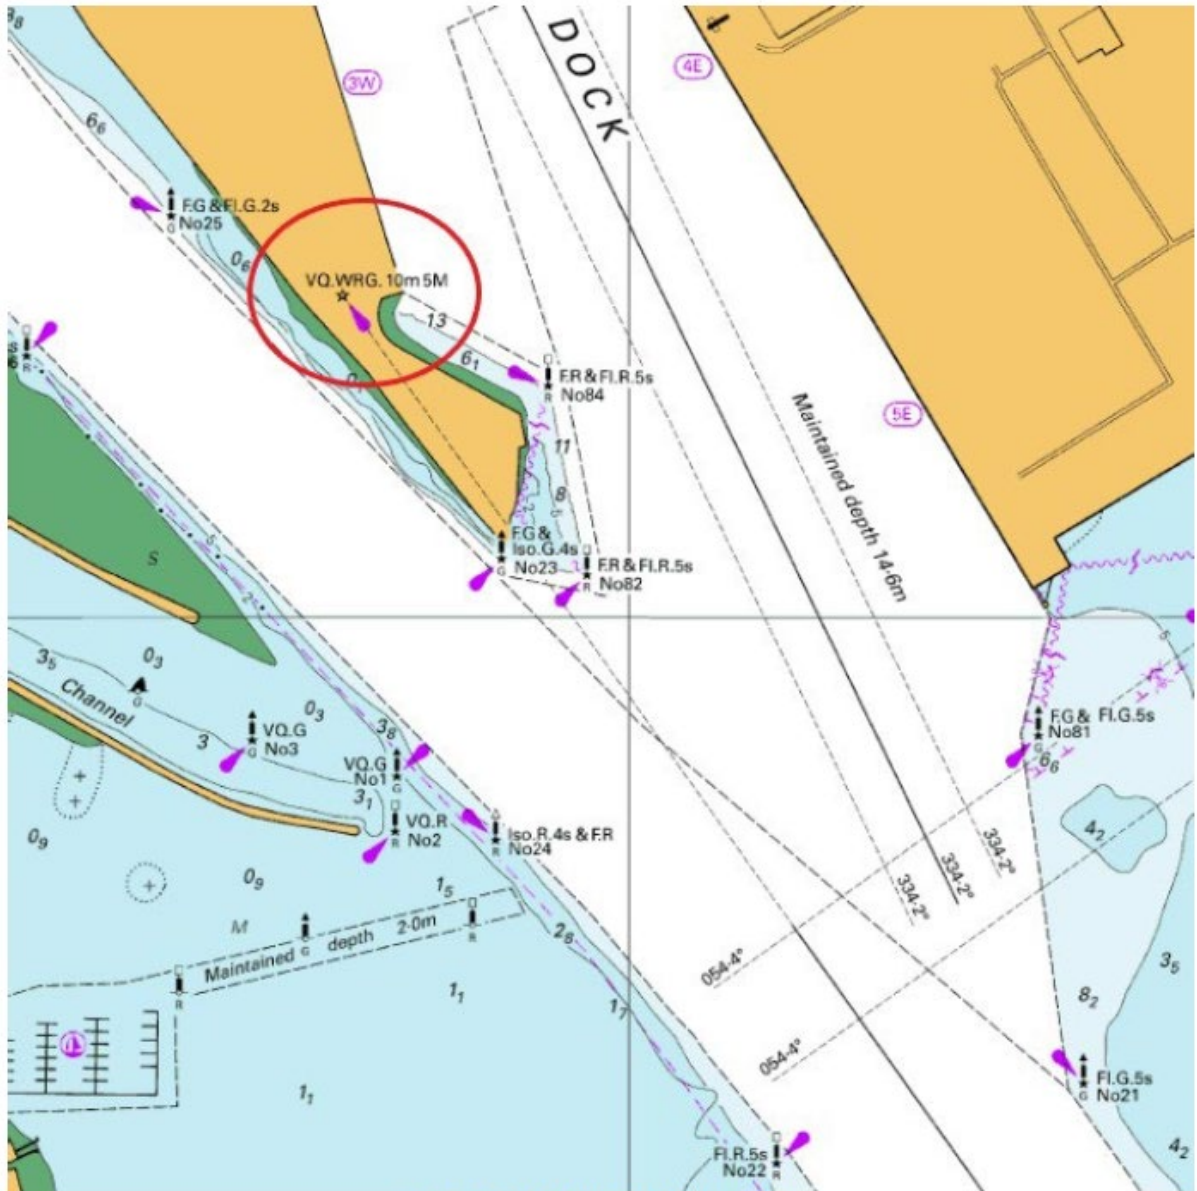
Details: Mariners are advised that Webb directional light, located in position **37° 50.842' S 144° 54.322' E**, is **unreliable**.

Mariners are advised to navigate with additional caution in the vicinity of Webb directional light.
