Victorian Notice to Mariners

No. 010 (T) - 2024

PORT OF MELBOURNE SWANSON DOCK LEADING LIGHTS UNRELIABLE

Date: 11 January 2024

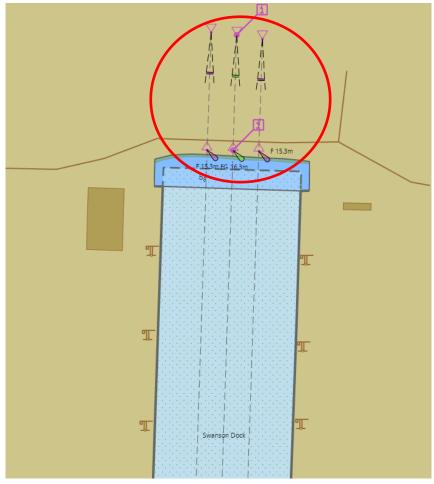
NOT FOR NAVIGATIONAL USE

Details: Mariners and port users are advised that the below listed Swanson Dock leading lights have recently experienced outages. Unexpected outages may continue and therefore the following leading lights should be considered unreliable:

K 2406-7	Ldg Lts 001 [.] 9°. Front. Centre	37°48∙56'S 144°54∙83'E	3 F G(vert)	16 m		3 green \triangle on pole
K 2406-71	Rear. Centre	37°48·46'S 144°54·83'E	3 F G(vert)	15 m		3 green \bigtriangledown on pole
K 2406-72	Front.East	37°48·56'S 144°54·86'E	FBu	15 m	••	Blue \triangle on pole
K 2406-721	Rear. East	37°48·46'S 144°54·86'E	FBu	16 m		Blue
K 2406-73	Front. West	37°48·56'S 144°54·80'E	FBu	15 m		Blue \triangle on pole
K 2406-731	Rear. West	37°48·46'S 144°54·81'E	FBu	16 m		Blue \bigtriangledown on pole

Melbourne VTS will advise vessels of the operational status of Swanson Dock leading lights prior to arrival and departure from Swanson Dock.

Mariners are advised to navigate with additional caution.
