GIPPSLAND PORTS

LNW No.11 OF 2021

PORT OF GIPPSLAND LAKES

No.5 BEACON DAMAGED – TEMPORARY LIGHT ESTABLISHED

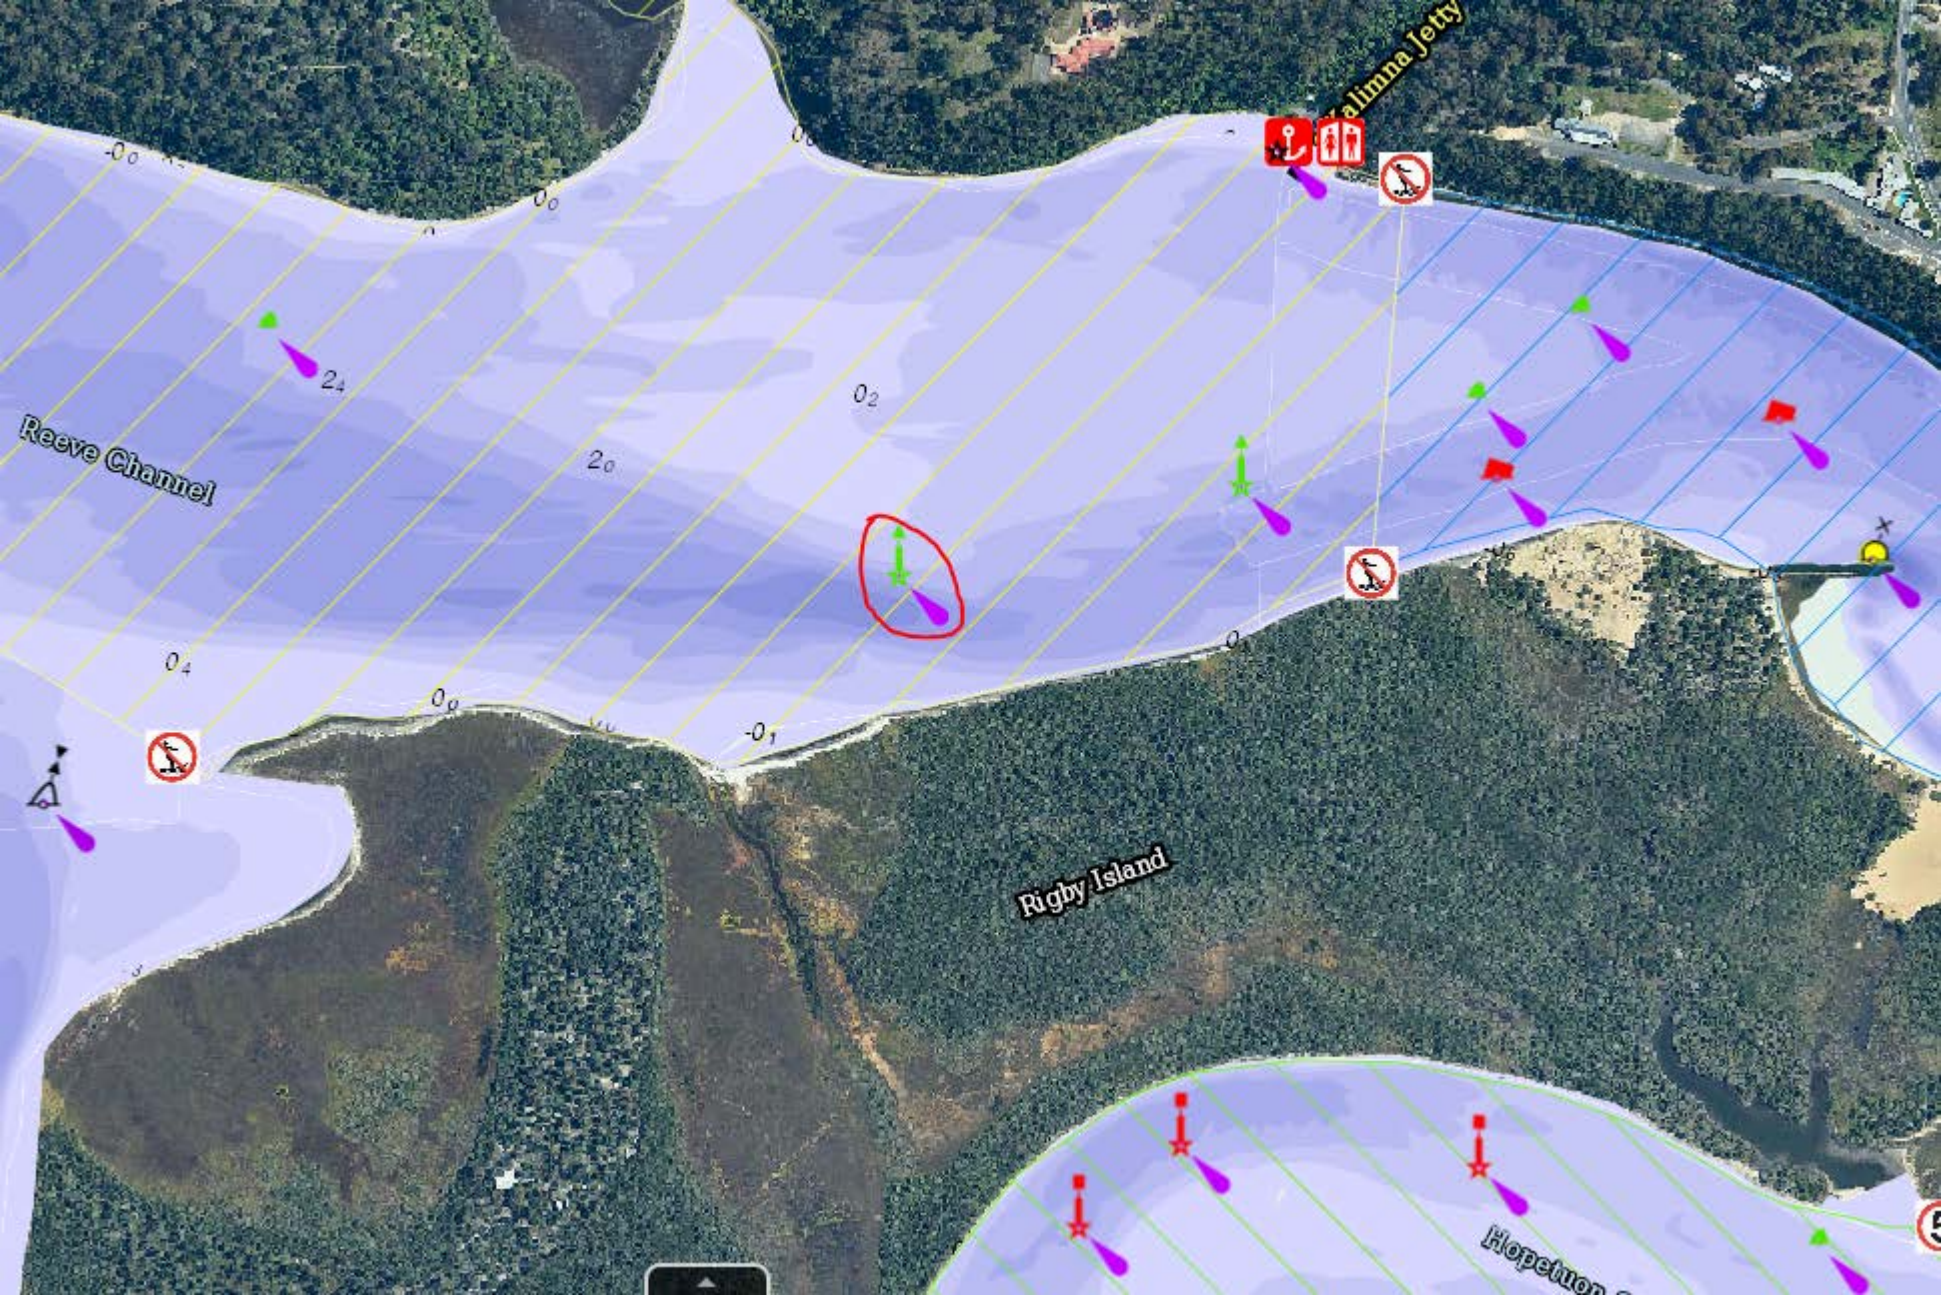
DETAILS: Mariners are advised that the Starboard Lateral Mark No.5 Beacon in The Narrows at Lakes Entrance has been damaged by vessel strike. The position of the No.5 Beacon is;
Lat. 37° 52.919' S
Lon. 147° 57.030' E Datum GDA94

The beacon has a substantial lean upstream and a temporary light (Fl.G.4s) has been re-established to the damaged beacon, pending remedial works to replace. The starboard top mark remains missing from the pile top.

Mariners are advised to take extra precaution when transiting the Narrows channel near No.5 Beacon.

A further notice will be issued when the beacon has been replaced.
